IIAR Natural Refrigeration Conference  
& Heavy Equipment Expo

## Technical Paper #9

# Lessons Learned from a Collection of Ammonia Incident Investigations

C'Anna Wiens P.E., Process Safety Engineer,  
Resource Compliance

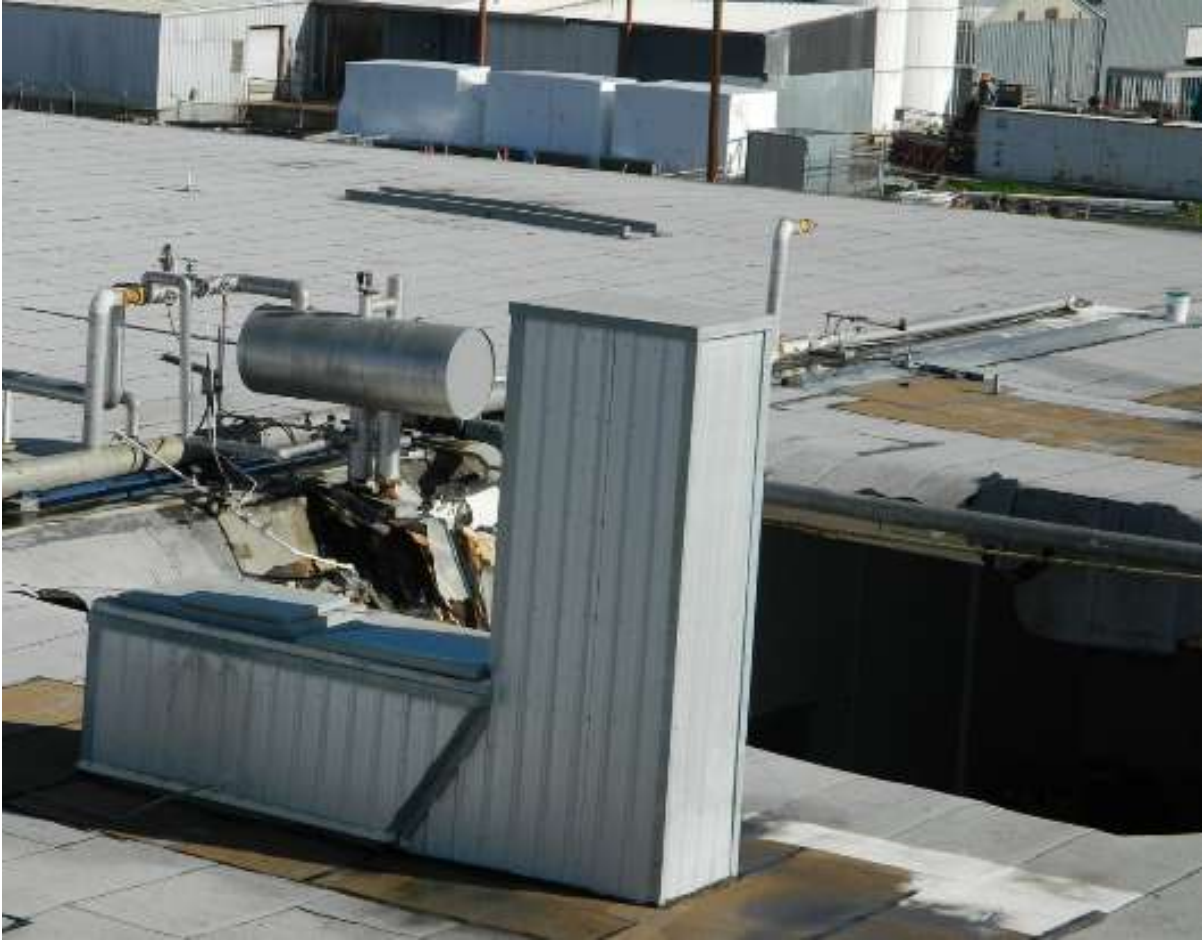
Figure 1. Collapsed Roof Viewed from Above

During a heavy rainstorm, the roof over a cold storage room collapsed. Two (2) ceiling-suspended evaporator coils fell with the roof, breaking the piping between the roof-mounted accumulator and the two coils. Additionally, a large water pipe broke and flooded the room. The facility was evacuated, and first responders were notified.

Insufficient roof drainage appears to be a contributing factor to the roof collapse. While it is unknown whether the roof structure was designed in accordance with the Building Code at the time it was installed, this incident illustrates the importance of monitoring the building structure and foundation. Even if a building is designed to code, decades of deterioration may result in a sudden collapse if not monitored and addressed.

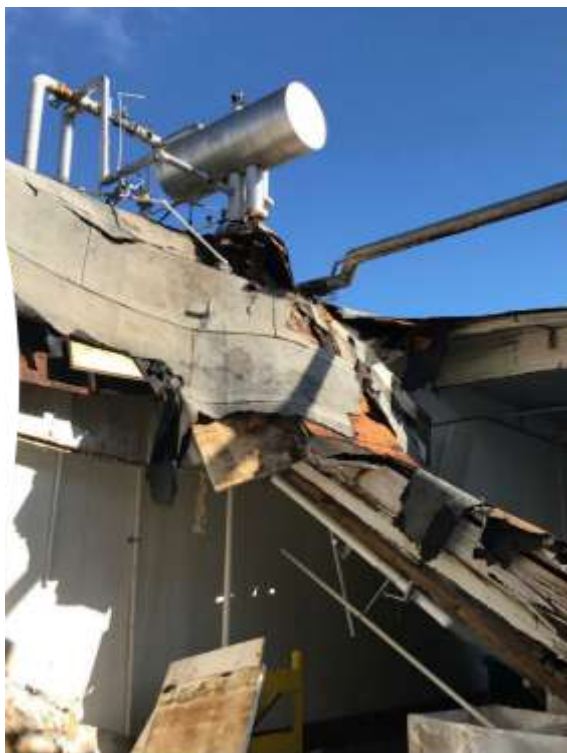
Figure 2. Collapsed Roof Viewed from Below

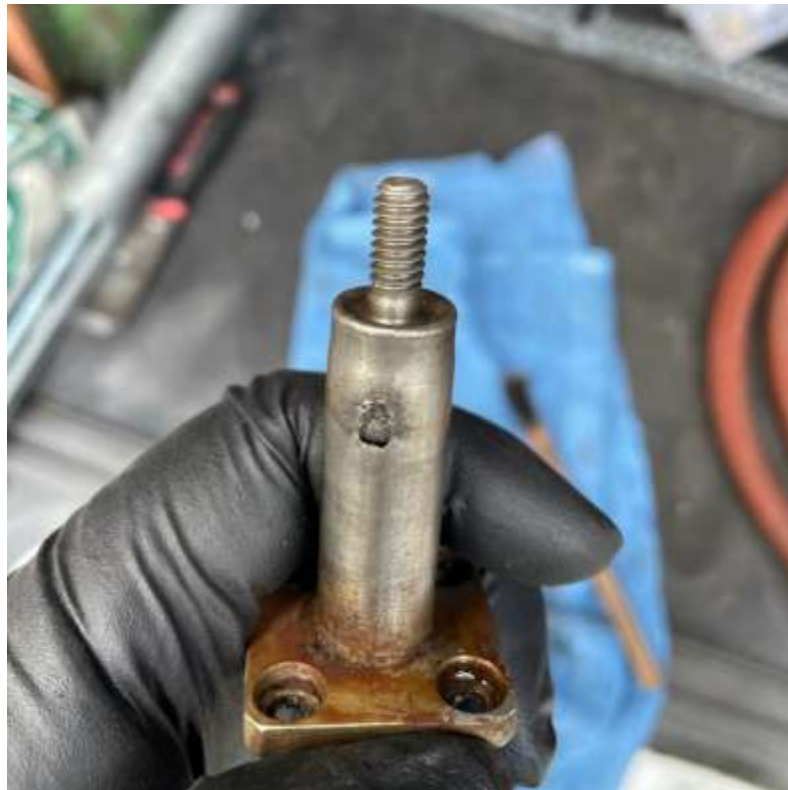
In September 2022, a solenoid coil grounded out against the plunger tube which burned a hole in the post of the valve as seen in Figure 3. This resulted in two injuries and the release of approximately 1,095 lbs. of ammonia.

Figure 3. Solenoid Valve Post After Leak

The root cause of the release was determined to be a failure/malfunction of the valve. Even when a system is well-maintained, mechanical failures can, and do, happen. Facilities should consider the location of valve groups in the event that a malfunction were to occur.

For example, evaporator valve groups are occasionally installed inside refrigerated spaces next to evaporator coils. If one of those valves malfunctions and causes a release, the ammonia would release indoors where employees may be exposed. Furthermore, accessing the isolation valves to mitigate the leak may be difficult. Valve groups located extremely high, or above stacked pallets/products may not be accessible with a lift or ladder in order to stop the leak. Ammonia refrigeration facilities should consider relocating valve groups from inside refrigerated spaces to the roof where they are more accessible during a leak.

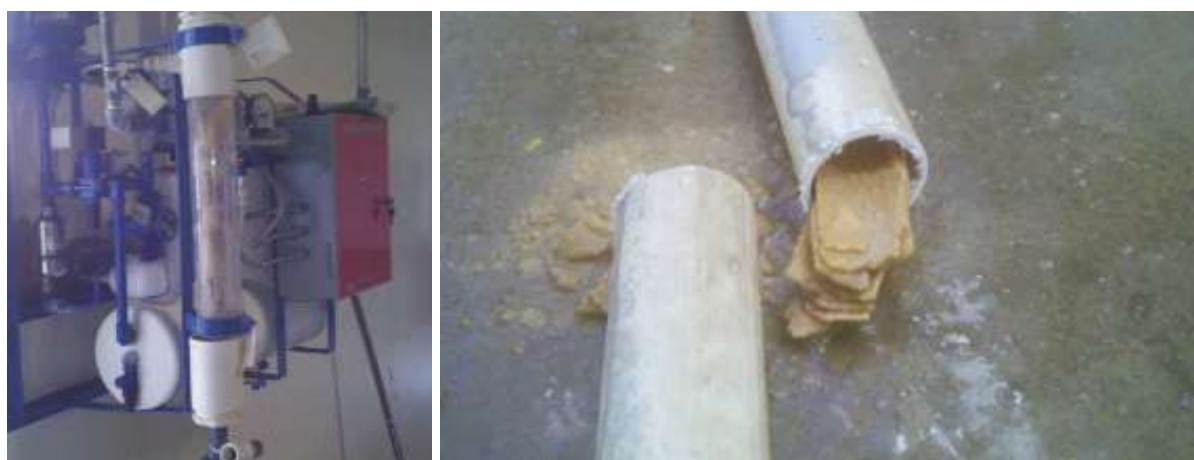
Water & mineral deposits were collected in the drain line of the auto-purger which eventually prevented water from draining freely from the bubbler (See Figure 5). As a result, water began to escape from the top of the bubbler where the  $\frac{1}{4}$ " vent is located.

Figure 5. Auto-Purger (Left) and Cut Bubbler Drainpipe (Right)

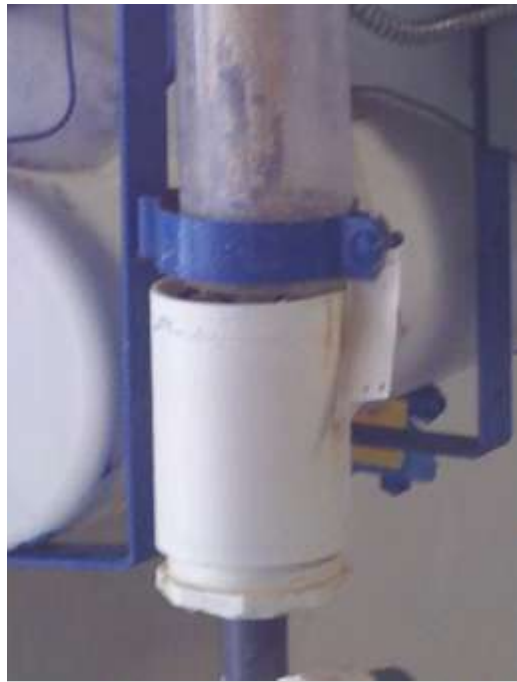
The two operators responsible for troubleshooting the situation failed to isolate and pump down the auto-purger before performing work. Instead, the vent hole was plugged, but the scale buildup in the drainpipe was not discovered or addressed. Since the water could no longer drain from the bubbler, the pressure rose when the auto-purger went through its normal purge cycle, and the bubbler ruptured (Figure 6). Both operators were standing near the bubbler and were splashed in the face with aqueous ammonia.

Figure 6. Base of Bubbler After Rupture

With further training regarding auto-purger operation and maintenance procedures, it is likely that the operators could have determined the root cause and avoided the incident altogether. Based on the approach taken to address the water leak, it can be assumed that the operators were not aware that the hole they plugged was a necessary vent port for proper drainage. Furthermore, if the auto-purger had been isolated and pumped down before performing work, the bubbler would not have over-pressurized while the operators were addressing the water leak.

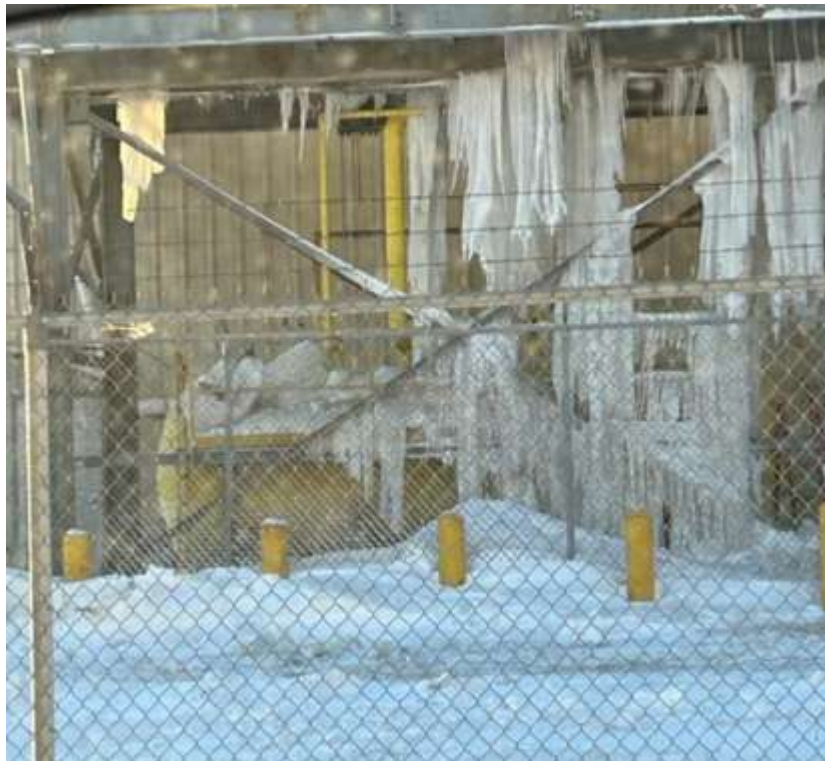
Figure 7. Ice Buildup Near the High Pressure Receiver

Extreme weather conditions resulted in excessive ice buildup under the condenser platform. The high pressure receiver was located under the condenser platform, where it was susceptible to falling ice. A portion of the ice fell onto a  $\frac{3}{4}$ " nipple associated with the high pressure receiver, shearing it off upstream of the charging connection check valve (See Figure 8).

Falling ice has the potential to both damage ammonia equipment, and cause injury to employees. While extreme weather conditions cannot be helped, ice buildup should be monitored and removed if the need arises.

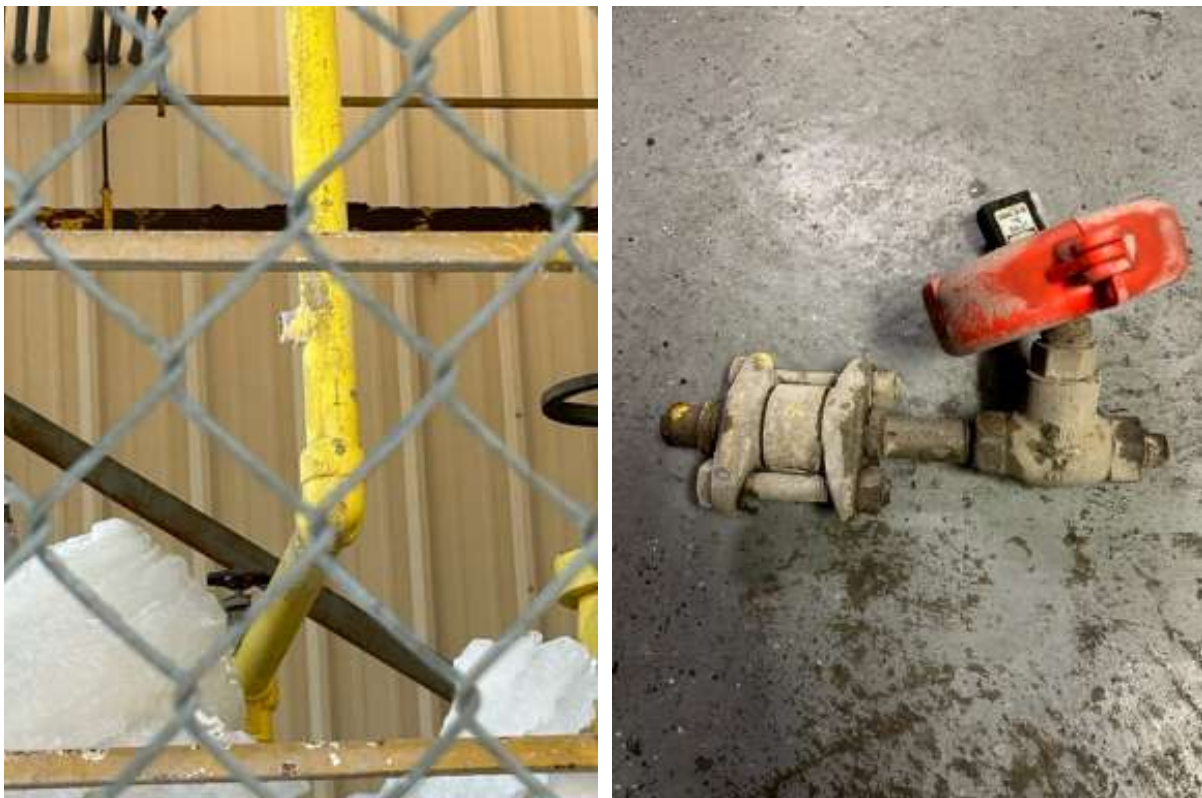
Figure 8. Location of Release (Left) and Broken off Piping/Valves

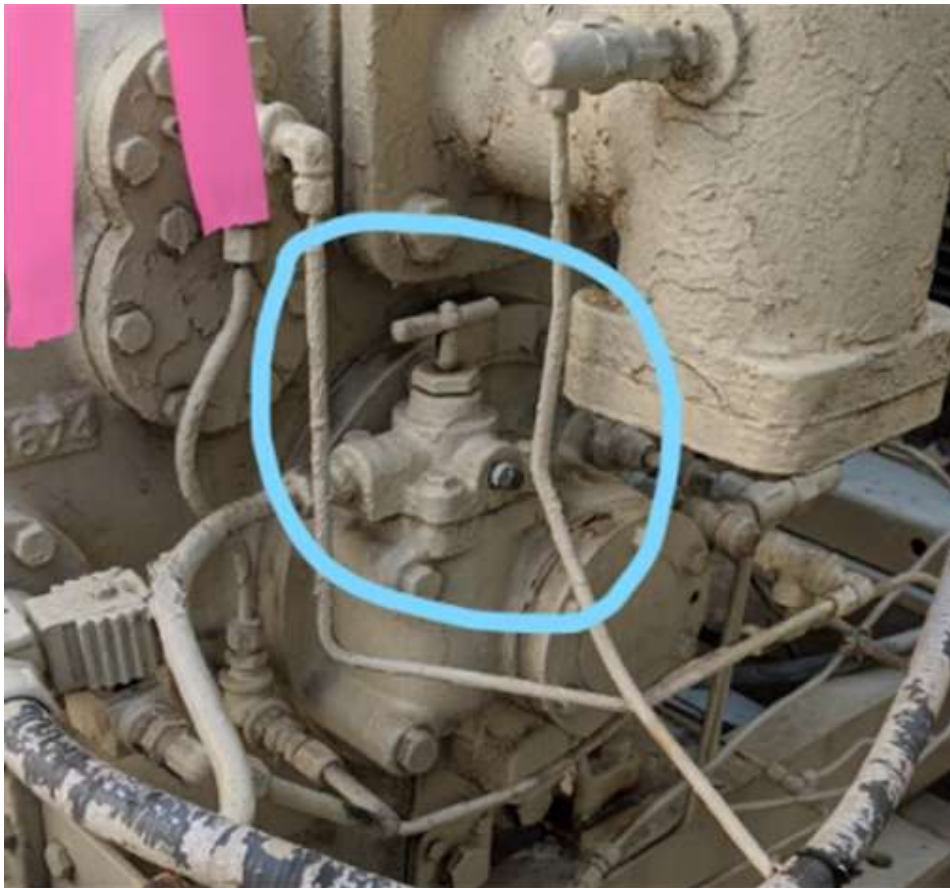
A brass plug was installed on a CUNO oil filter (See Figure 10) several years prior. Over time, the ammonia ate away at the brass until the plug failed, releasing an ammonia/oil mixture. An anonymous person called 911 to report the smell of ammonia.

Figure 10. CUNO Oil Filter

Brass, copper, and galvanized steel will corrode in the presence of ammonia as demonstrated by this event. Operators and contractors should take care to ensure that only compatible materials are used in ammonia systems. The inspection checklist in ANSI/IIAR 6-2019 Appendix B<sup>2</sup> can be a helpful reminder to inspect materials used in the system and ensure their compatibility (See Figure 12).

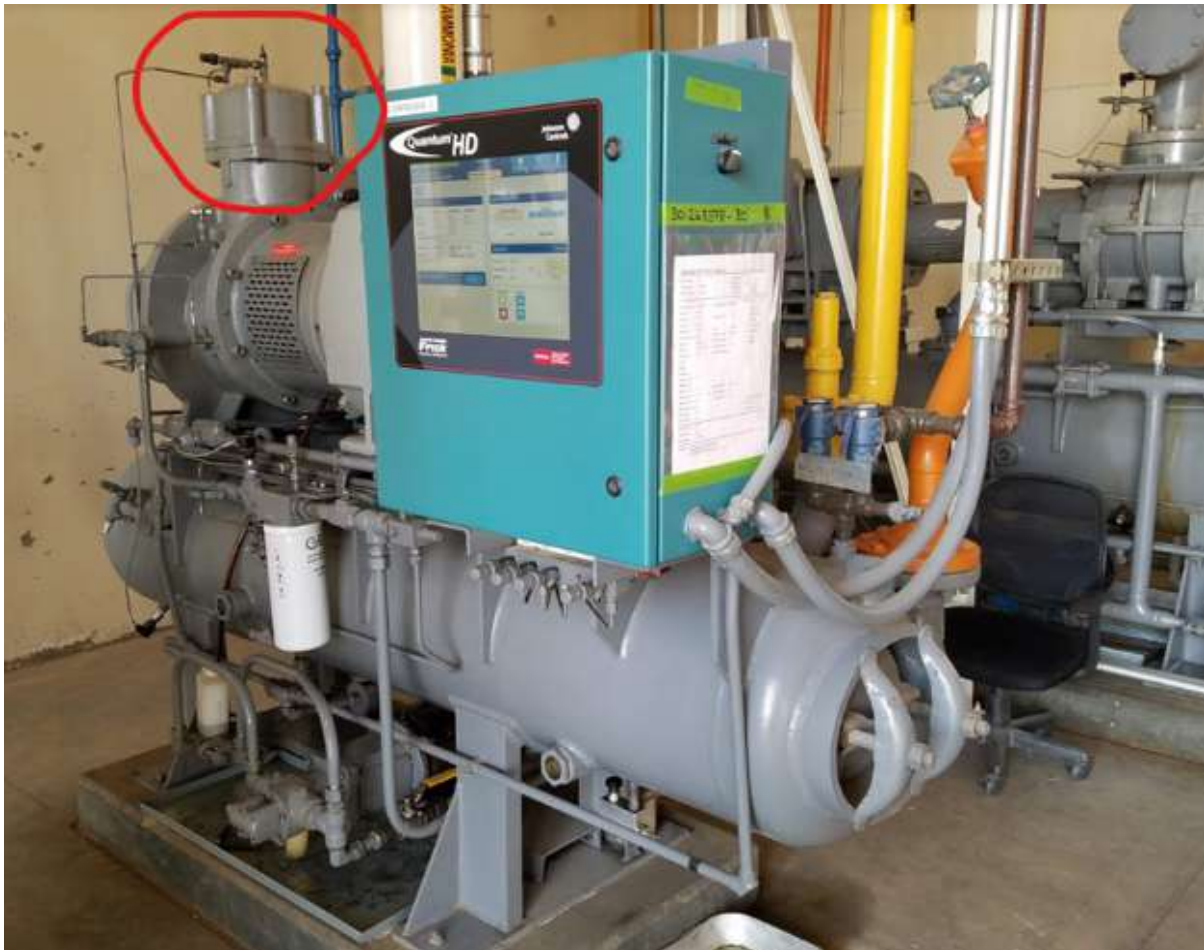
Figure 14. Location of the Ammonia Release

The cause of the release appeared to be the first broken bolt on the suction strainer cap. The mechanical integrity records were reviewed in order to determine when the bolt broke, and whether the inspecting contractor identified it.

In the end, it was determined that the facility did not properly review the mechanical integrity report when it was delivered. Although inspection reports may sometimes be confusing or contain an overwhelming amount of information, it is important to ensure each recommendation is reviewed and addressed accordingly.

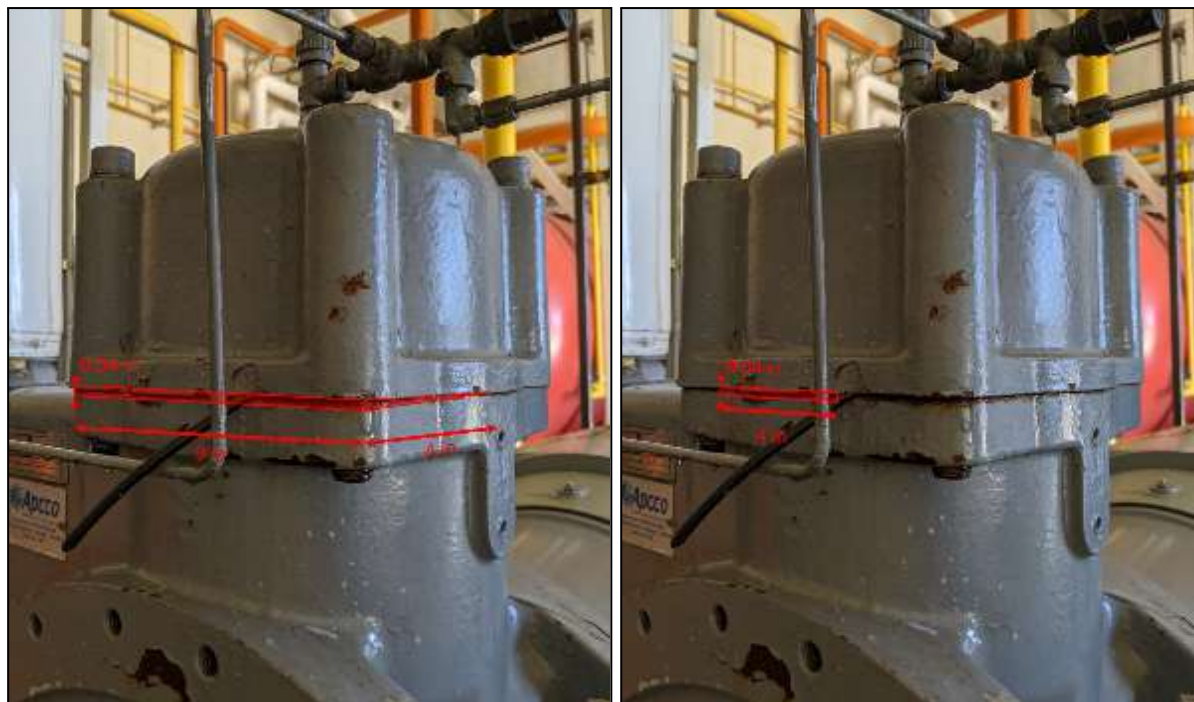
*“A gasket inside the strainer tore and approximately four inches of the gasket was forced out of the strainer at the time of the release. Due to the nature of the hole, two area calculations were performed: one area calculation assuming the largest possible hole area, and another assuming the smallest possible hole area.”*

Figure 15. Largest Hole Area (Left) and Smallest Hole Area (Right)

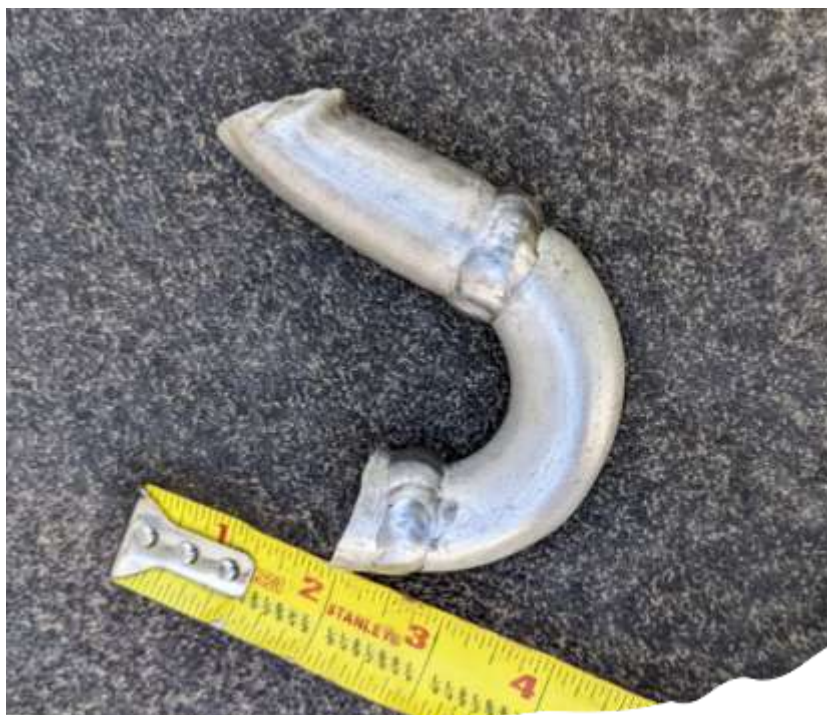
In August 2022, hydrostatic expansion occurred inside an improperly isolated evaporator coil, resulting in a release of approximately 230 lbs. of ammonia. The leak occurred when one of the return tubes of the evaporator coil broke due to the over-pressurization (See Figure 16).

Figure 16. Broken Evaporator Return Tube

This incident illustrates the danger of hydrostatic expansion and the type of damage that can be caused. In order to prevent liquid ammonia from being trapped in an ammonia system, facilities should ensure that vessels are not filled beyond 85%, and purge valves are installed at valve groups where the automatic trapping of liquid can occur.

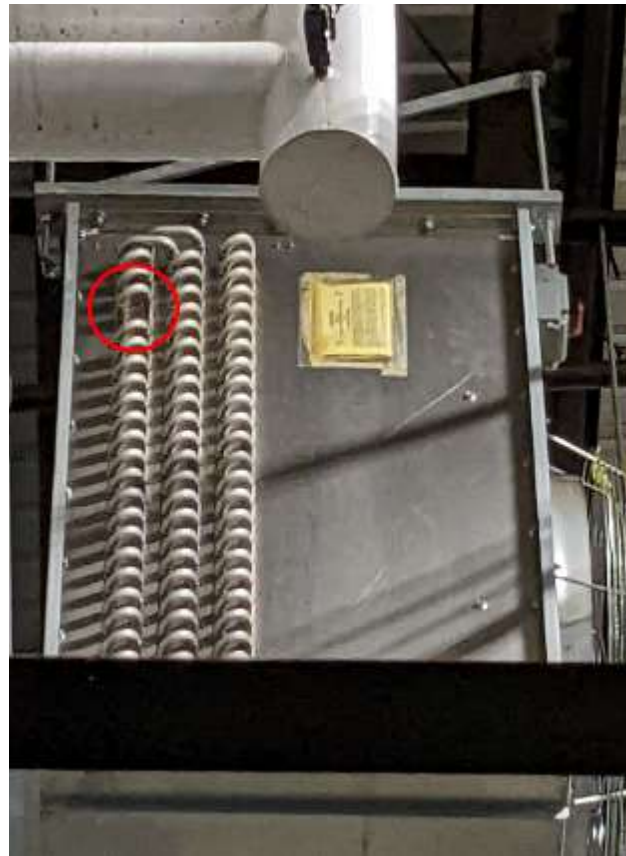
Over several days, ammonia vapor entered from the suction pipe shared with Coils 1-2. It is suspected that the vapor condensed inside the coil over time. The night of the incident, the zone went into a water defrost cycle. This raised the temperature of the coils and the liquid/vapor mix in Coil 3 rapidly expanded. Since the suction valve was slightly cracked, the ammonia could not return fast enough. This built excessive pressure, causing the coil return tube to break at the location indicated in Figure 17.

Figure 17. Location of Broken Return Tube

The contributing factors to the release appear to be a contractor error, and impatience of the facility to start cooling the room. An error was made by the contractor in not opening the suction valve enough to allow for hydrostatic expansion to occur. Reportedly, the construction crew did not consult with the refrigeration service or engineering department before adjusting the valves on the evaporator after the pressure test. Had they obtained instructions or been supervised by another department, the suction valve would have been left fully open, or fully closed after ensuring the evaporator was empty of ammonia.

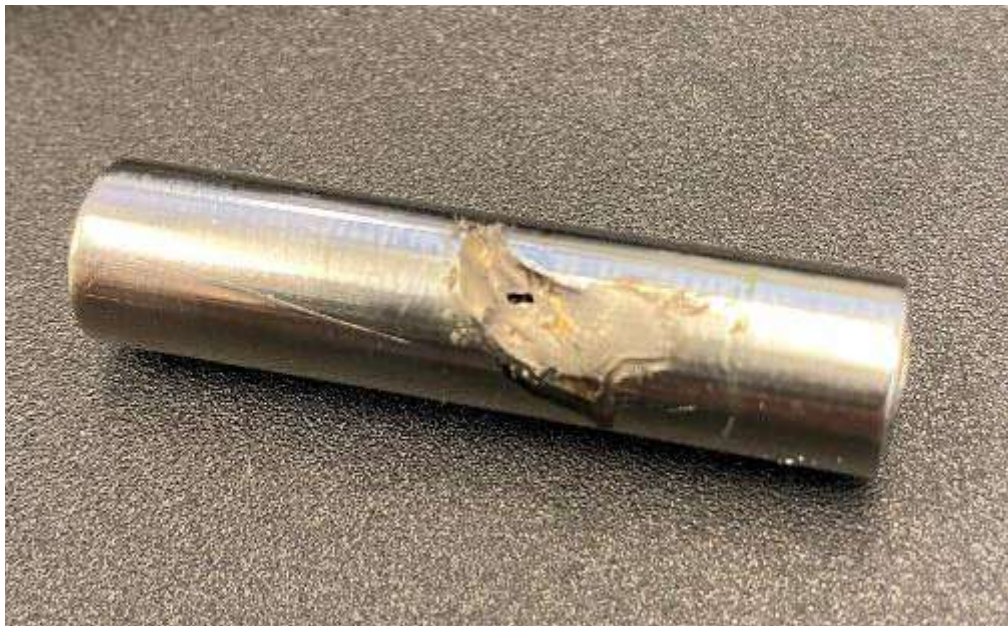
In June 2023, the vibration of an evaporator over an extended period of time allowed exposed electrical wiring to cause an arc flash that ruptured a distribution tube (See Figure 18). This resulted in two (2) injuries and a release of approximately 11 lbs. of ammonia.

Figure 18. Damaged Distribution Tube

Maintenance and upkeep on electrical components might often be overlooked at a facility. Ensuring that wire insulators are in good condition can prevent an arc flash as seen here, and corrosion/deterioration of the exposed wire.

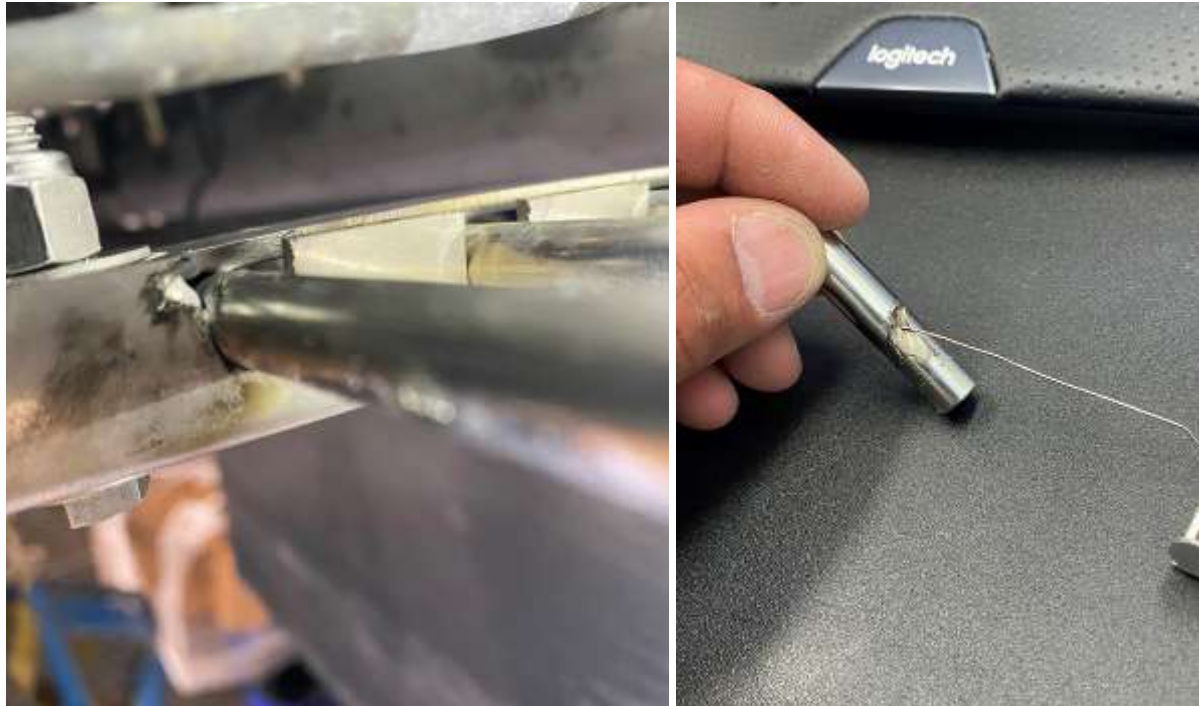
The direct-expansion evaporator was equipped with an electric heater defrost pad. The associated electrical wiring insulator wore through due to the vibration of the evaporator over an extended period of time. The exposed electrical wiring came into

contact with the TX valve distribution tubes, causing an arc flash that ruptured a distribution tube and created the damage shown below in Figure 19.

Figure 19. Damaged Distribution Tube on the Evaporator (Left) and Distribution Tube Hole Diameter After Removal (Right)

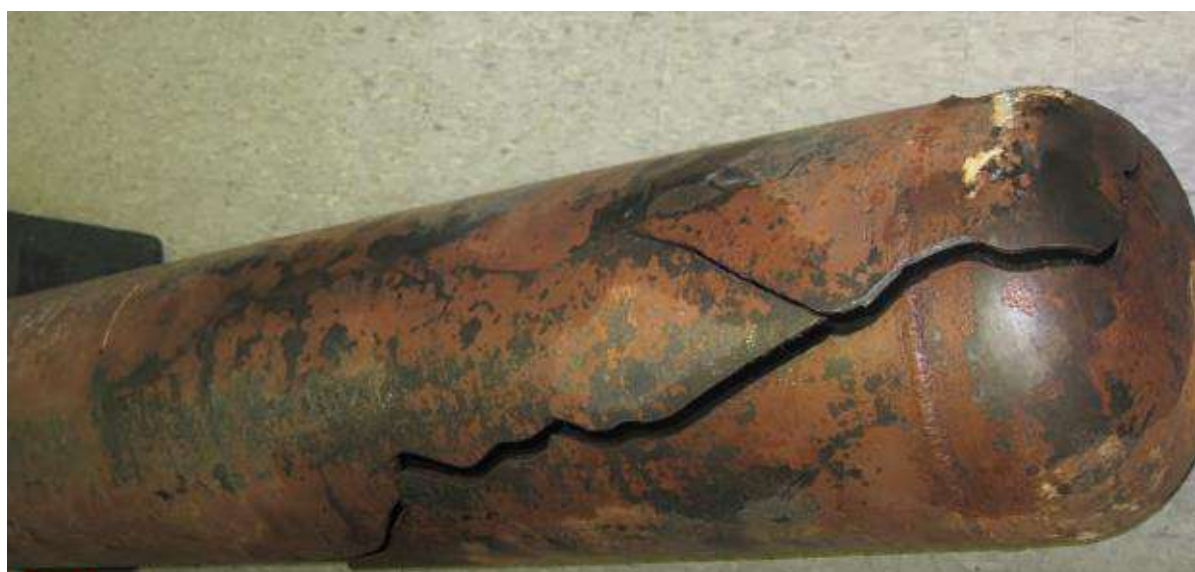
Select evaporators were in the process of hot gas defrost when the facility lost power for several hours. Once power was restored, the refrigeration system automatically resumed the defrosting process. Using the computer control system, a programming error caused the defrost cycle to be interrupted and refrigeration mode initiated when an operator cleared an alarm related to the power failure. Cold liquid ammonia was sent to the defrosting evaporator, containing warm vapor ammonia. The combination of the hot gas and cold liquid resulted in rapid depressurization and two pipe ruptures, including a 12" pipe located on the roof of the facility (Shown in Figure 21).

Figure 21. Cracked 12" Pipe

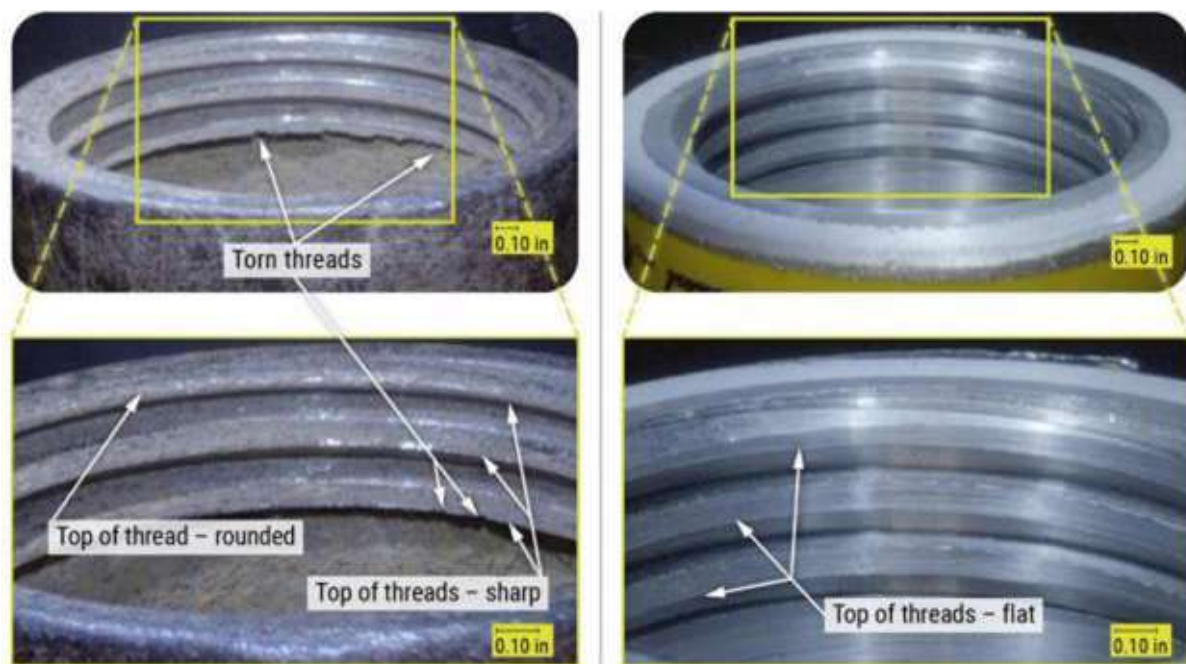
After further investigation, it was discovered that the threads of the coupling had deteriorated from age and corrosion (See Figure 23). This was determined to be the underlying cause of the coupling unscrewing during transportation.

Figure 23. Coupling Threads - Image courtesy of the National Transportation Safety Board

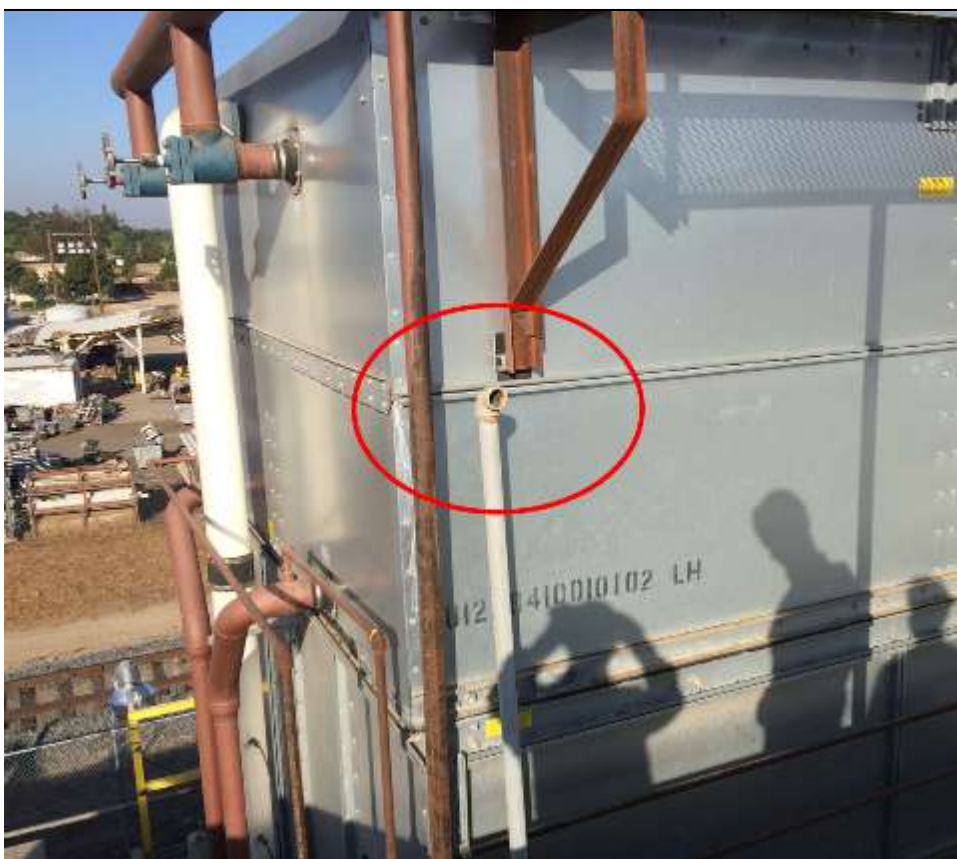
exhaust fan pulled ammonia vapor into a highly populated room in the processing facility which exposed thirty-four employees to ammonia. The ammonia was released from the relief vent discharge pipe circled in Figure 24.

Figure 24. Relief Vent Discharge Pipe

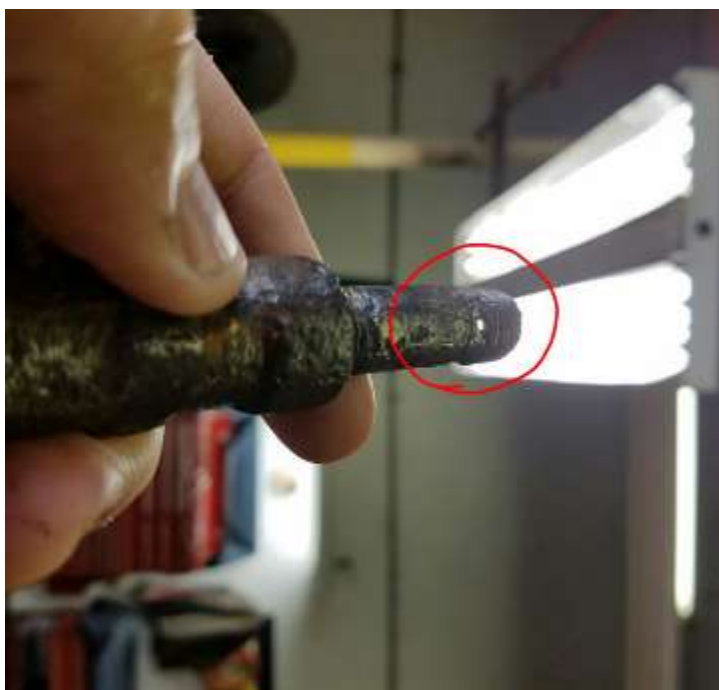
In June 2016, a hole developed in the nipple of a ½" service valve (See Figure 25), resulting in a release of 1,224 lbs. of ammonia. The service valve, installed on a liquid transfer vessel, began leaking liquid ammonia into the machinery room.

Figure 25. Hole in the ½" Service Valve

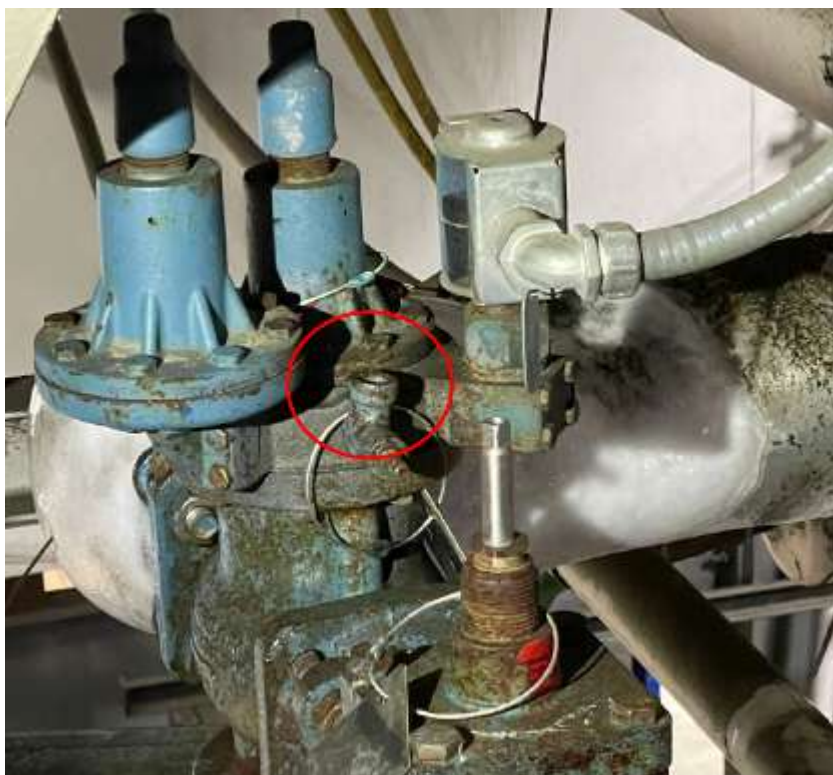
Figure 26. Service Valve Left Open to Atmosphere

Approximately one week later, an operator was performing daily rounds and noticed that the temperature in one of the cold storage rooms was high. In order to lower the temperature in the room, he opened the liquid feed isolation valve for the valve group that had previously been isolated for maintenance. Upon opening the valve, he heard a hissing sound, so he quickly closed the valve again. Between the time that the isolation valve was opened and closed, ammonia escaped from the service valve.

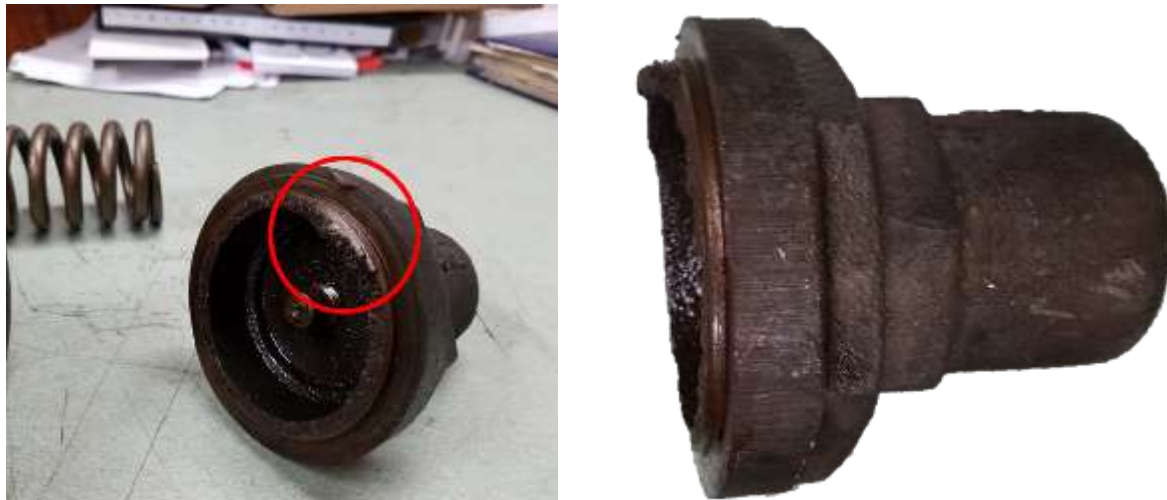
In August 2016, the sudden breaking of a valve on an ammonia pump resulted in the release of 34-284 lbs. of ammonia. The root cause was determined to be a stress crack that formed at the threads of a valve (See Figure 27), ultimately leading to the top of the valve shearing off.

Figure 27. Sheared Off Valve

Investigation into the incident revealed that the stress crack formed from years of frosting and thawing cycles. The cycles allowed water to freeze and expand, then contract as the ice melted. This phenomenon is commonly seen on roadways where freezing and thawing of water results in crack formation.

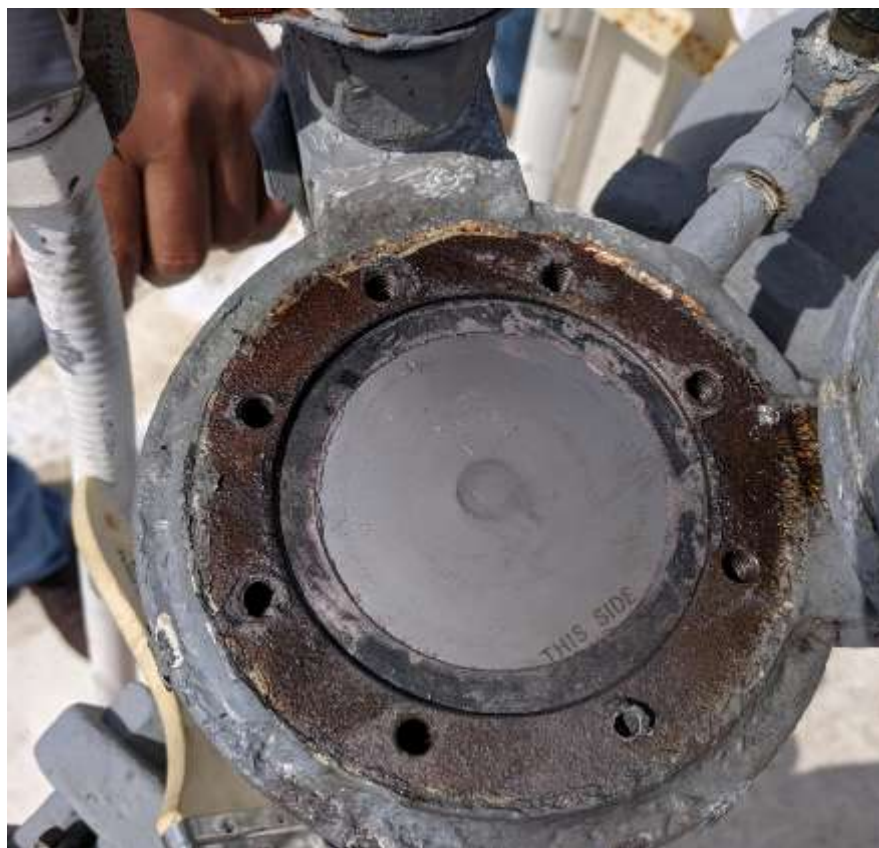
The cause of the incident was determined to be an equipment malfunction of the suction regulator. The internal components of the valve had been inspected two months prior to the incident. Therefore, it is unlikely that inadequate maintenance is a contributing factor. Figure 28 shows the partially disassembled suction regulator with no indications of improper maintenance.

Figure 28. Partially Disassembled Suction Regulator

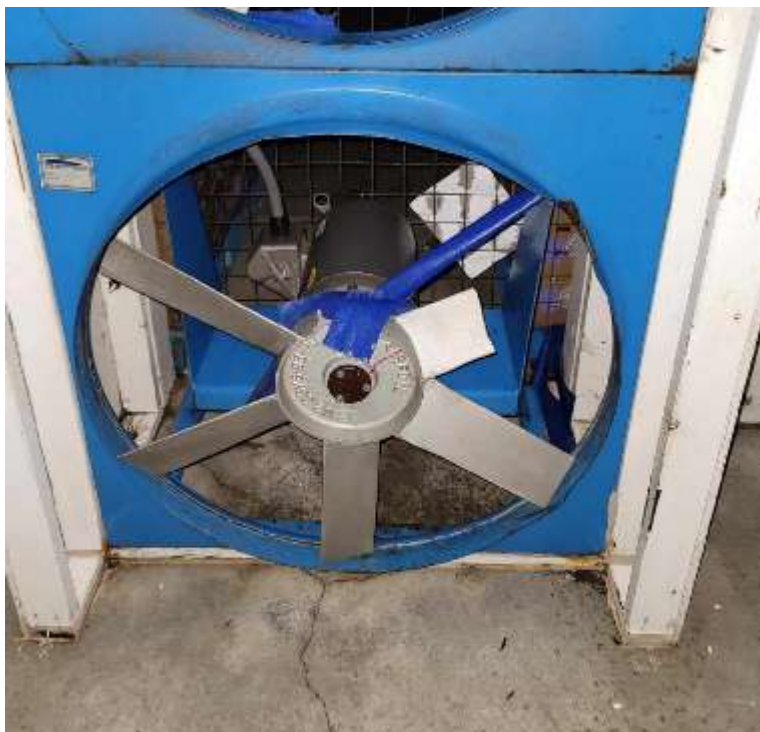
Inside the room, a small tarp is used to wrap product pallets to produce more efficient cooling. A small piece of tarp was able to slip through the fan guard and was sucked into the fan. Two of the fan blades broke (See Figure 29) and flew upwards into one of the bunker evaporator coils. The fan blades punctured two holes in the coil (See Figure 30) which caused the release.

Figure 29. Broken Fan Blade

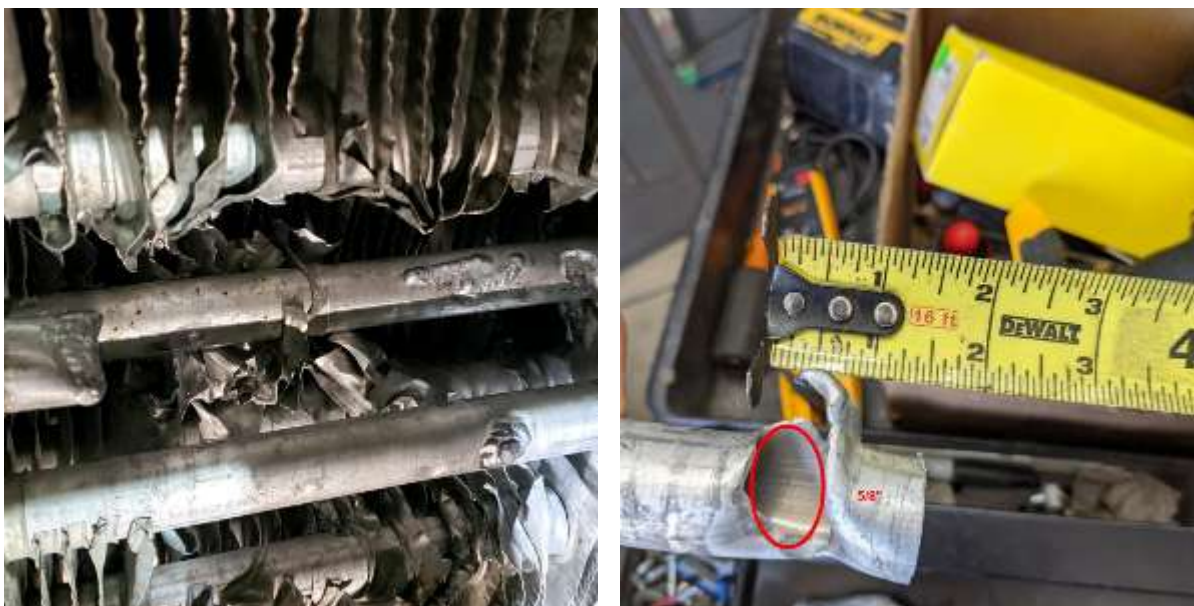
Figure 30. Evaporator Coil Damage
