# Technical Paper

IIAR Natural Refrigeration Conference  
& Heavy Equipment Expo

## Technical Paper #5

# Cues and Confirmation Your Piping is in Jeopardy: A Comparison of 20+ Years of NDT Data with Field Observations

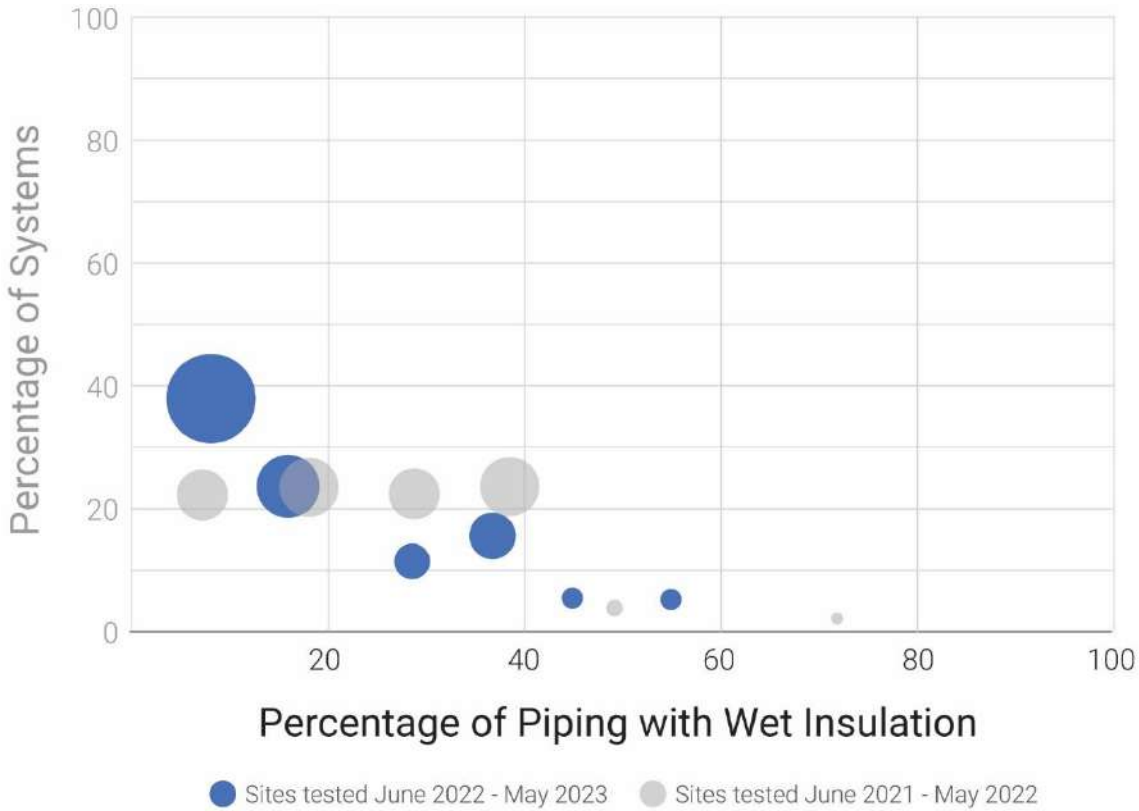
On average, 20% of aging ammonia refrigeration systems contain some level of rogue moisture in the piping insulation, but no systems exhibited moisture in 100% of the piping insulation, as seen in Figure 1. Protective measures to combat rogue moisture in the insulation have been partially effective, considering that these figures continue to decline (down from 30% in 2015). Furthermore, the lowest recorded percentage of water trapped in the ammonia piping insulation evaluated by visual inspection between June 2022 and May 2023 was ~10%, for ~40% of the systems, and the highest percentage of wet insulation was ~55%, for ~5% of the systems.

Figure 1. Based on a study of systems evaluated in the U.S. between June 2022 and May 2023.

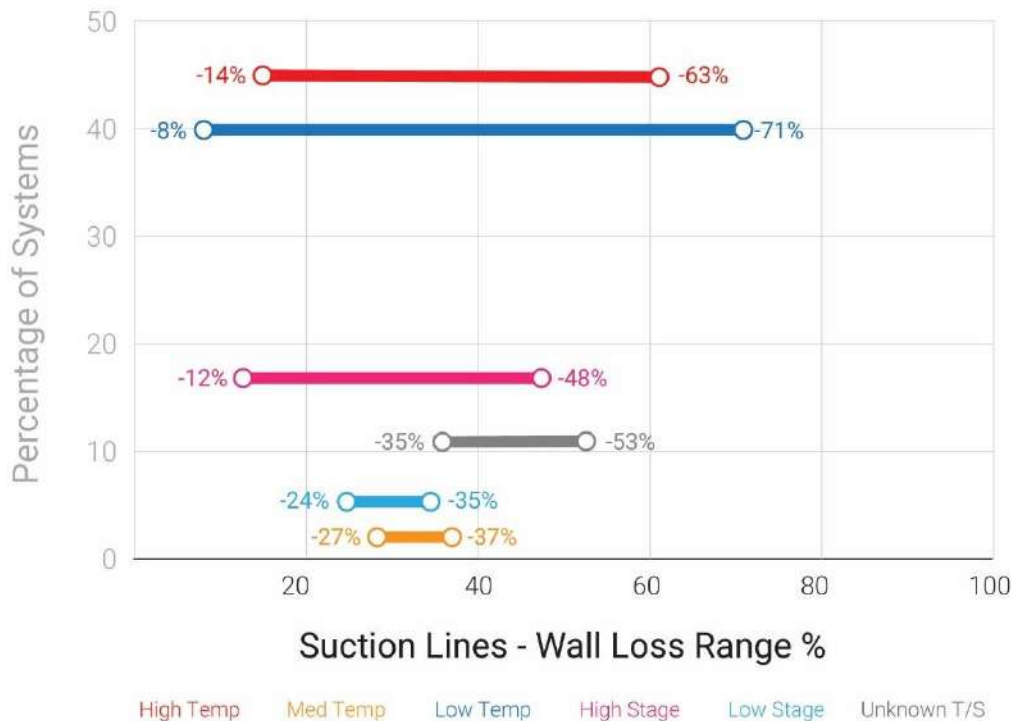
As seen in Figure 2, for example, pipe wall loss can be as high as 71% on low-temperature suction lines. In aggregate, 81% of systems exhibited pipe wall loss due to CUI on a suction line at the time of testing. Overall, 43% of the evaluated systems were reported to have areas with pipe wall loss of over 50%. The highest recorded loss, not including leaks that occurred as a result of complete metal integrity failure due to corrosion, peaked at 82% wall loss (or 18% remaining wall thickness).

Figure 2. Based on a study of systems evaluated in the U.S. from June 2022 to May 2023.

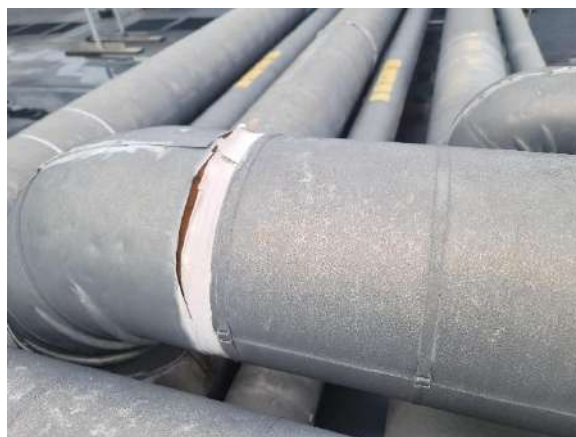
1. Jacketing separation (see Figure 3)
2. Holes in the insulation
3. Hail damage
4. Split seams
5. Crushing from physical damage
6. Weld strikes or other electrical damage that penetrate the jacketing

Figure 3. Jacketing separation and split seam

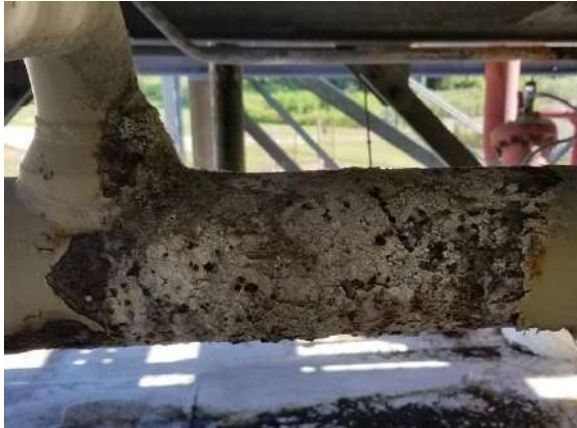
1. Piping near condensers or a cooling tower area. This equipment can produce chemical and mineral-rich mists that are especially damaging to pipe jacketing and bare piping (see Figure 4). This mist can leave mineral deposits on metal surfaces, which are prone to corrosion unless cleaned and coated regularly. This is especially detrimental for piping that is not properly protected, like in areas where piping penetrates the walkways, or when the design does not allow for enough room to thoroughly inspect or properly maintain coatings.

Figure 4. Chemically induced corrosion on bare piping.

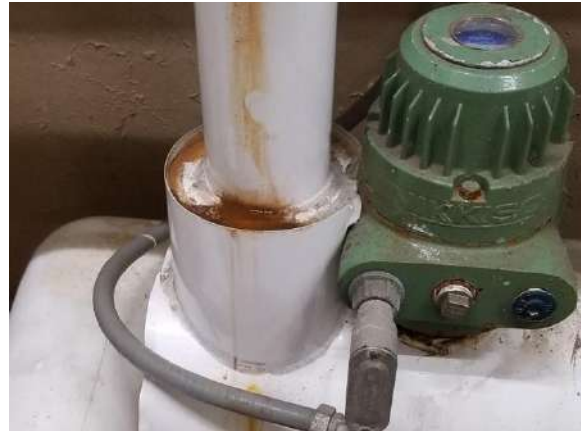
2. Gravitational pooling also requires for consideration, specifically related to pump outs and roof penetrations (see Figure 5). Pump outs are commonly installed in the bottom of piping for proper function. However, this positions the piping precisely in the area that collects water after being compromised. Water collects in the lowest area, beneath the piping or in dips of the roof.

Figure 5. Water pooling at the base of insulated ammonia piping at pump out.

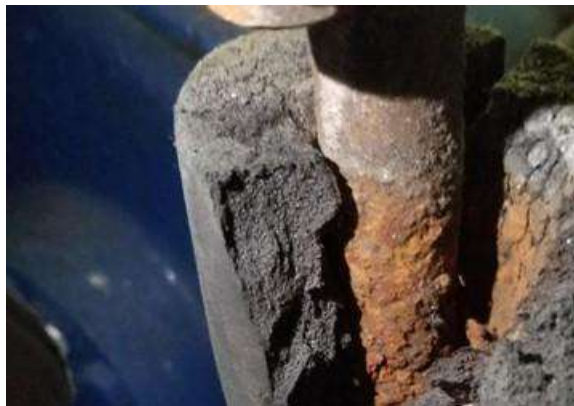
7. Fiberglass and elastomeric foam insulation, commonly used for residential air conditioning and plumbing, are prone to waterlogging and should not be used (see Figure 6). Furthermore, elastomeric foam insulation is commonly glued to the surface of the pipe with no outer protection from the elements, which is a sign of imminent damage.

Figure 6. Elastomeric foam insulation on ammonia piping.

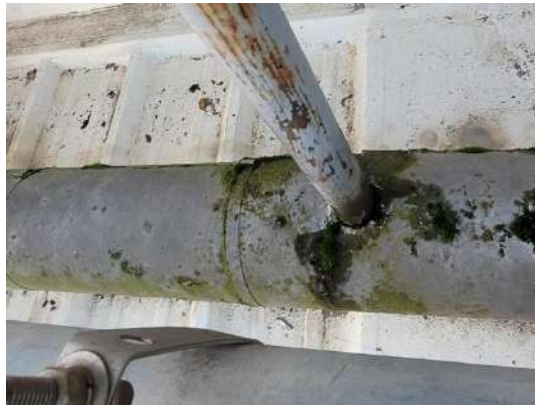
2. Biological indicators, such as algae, moss, or plants, growing on the insulation (see Figure 7).
3. Rust stains on the insulation jacketing. Rust staining or rust-colored water from within the jacketing occurs as a result of degradation in the piping or components contained inside the jacketing and insulation.

Figure 7. Algae on the ammonia pipe jacketing.

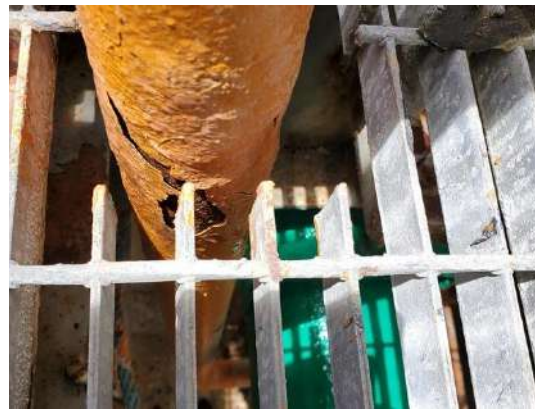
Where corrosion is present, the remaining pipe wall must be measured to make an accurate assessment of the severity, which is related to the level of priority. Corrosion on bare piping and CUI take on multiple forms and vary in terms of how aggressively they advance. Generally, blister rust is the most concerning form (Figure 8). If the piping shows layers of peeling rust (or blistering), the corrosion is advanced, and the remaining wall thickness is likely not suitable for operation. The general rule of thumb for companies that exercise a conservative approach is to immediately replace piping that exceeds 50% wall loss.

Figure 8. Blister rust/corrosion.

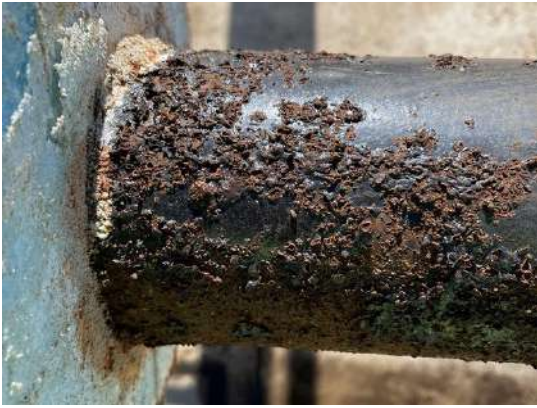
Pitting corrosion is the most common form of corrosion found in refrigeration systems (Figure 9). Pitting is usually a slow process that causes isolated, scattered pits over a localized area. Contrary to blister rust, pitting and swelling rust (Figure 10) both look severe, though oftentimes the piping can remain in service. Where piping has suffered wall loss in the range of 30%–50%, the pipe needs to be cleaned of all corrosion and coated to protect it from moisture.

Figure 9. Pitting rust/corrosion.

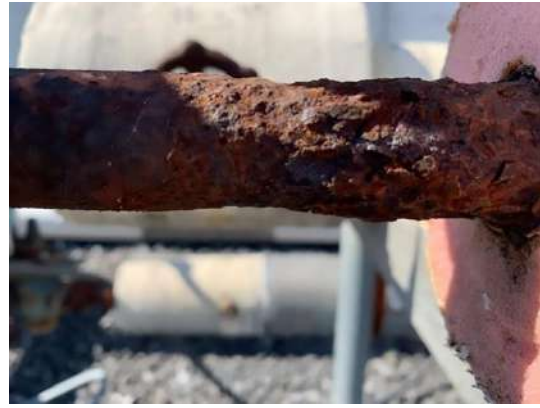
Figure 10. Swelling rust/corrosion.
