IIAR Natural Refrigeration Conference  
& Heavy Equipment Expo

## Technical Paper #9

# Lessons Learned from a Collection of Ammonia Incident Investigations

C'Anna Wiens P.E., Process Safety Engineer,  
Resource Compliance

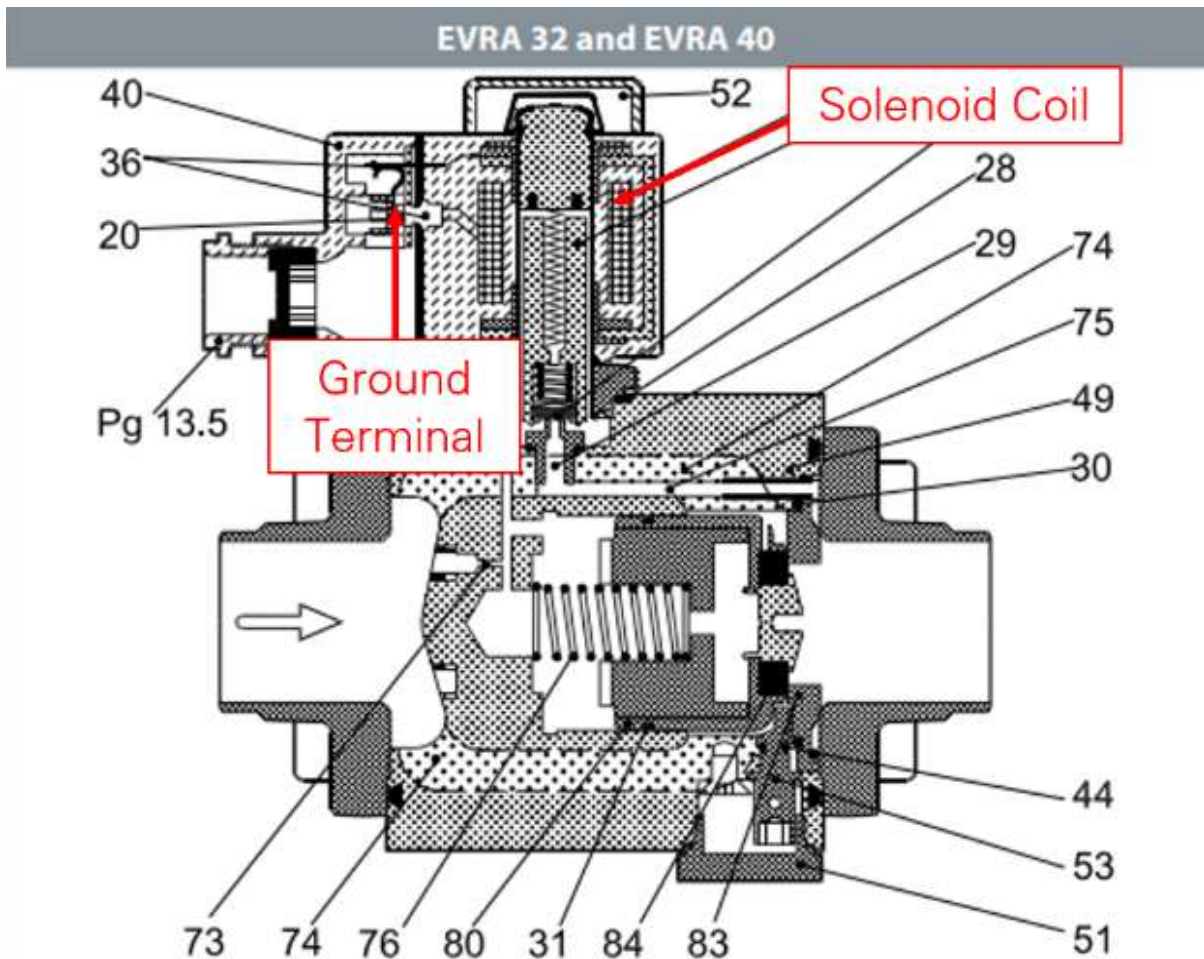
Figure 4. Solenoid Valve Diagram

In September 2022, a solenoid coil grounded out against the plunger tube which burned a hole in the post of the valve as seen in Figure 3. This resulted in two injuries and the release of approximately 1,095 lbs. of ammonia.

Damage to the solenoid coil allowed the “live” coil to make contact with the “ground” terminal inside the valve. This sudden spike in voltage created an arc flash inside the valve. The arc flash burned a hole in the armature, which allowed the ammonia to escape through the valve. The locations of the solenoid coil and ground terminal in a solenoid valve are illustrated below in Figure 4.

The root cause of the release was determined to be a failure/malfunction of the valve. Even when a system is well-maintained, mechanical failures can, and do, happen. Facilities should consider the location of valve groups in the event that a malfunction were to occur.

For example, evaporator valve groups are occasionally installed inside refrigerated spaces next to evaporator coils. If one of those valves malfunctions and causes a release, the ammonia would release indoors where employees may be exposed. Furthermore, accessing the isolation valves to mitigate the leak may be difficult. Valve groups located extremely high, or above stacked pallets/products may not be accessible with a lift or ladder in order to stop the leak. Ammonia refrigeration facilities should consider relocating valve groups from inside refrigerated spaces to the roof where they are more accessible during a leak.

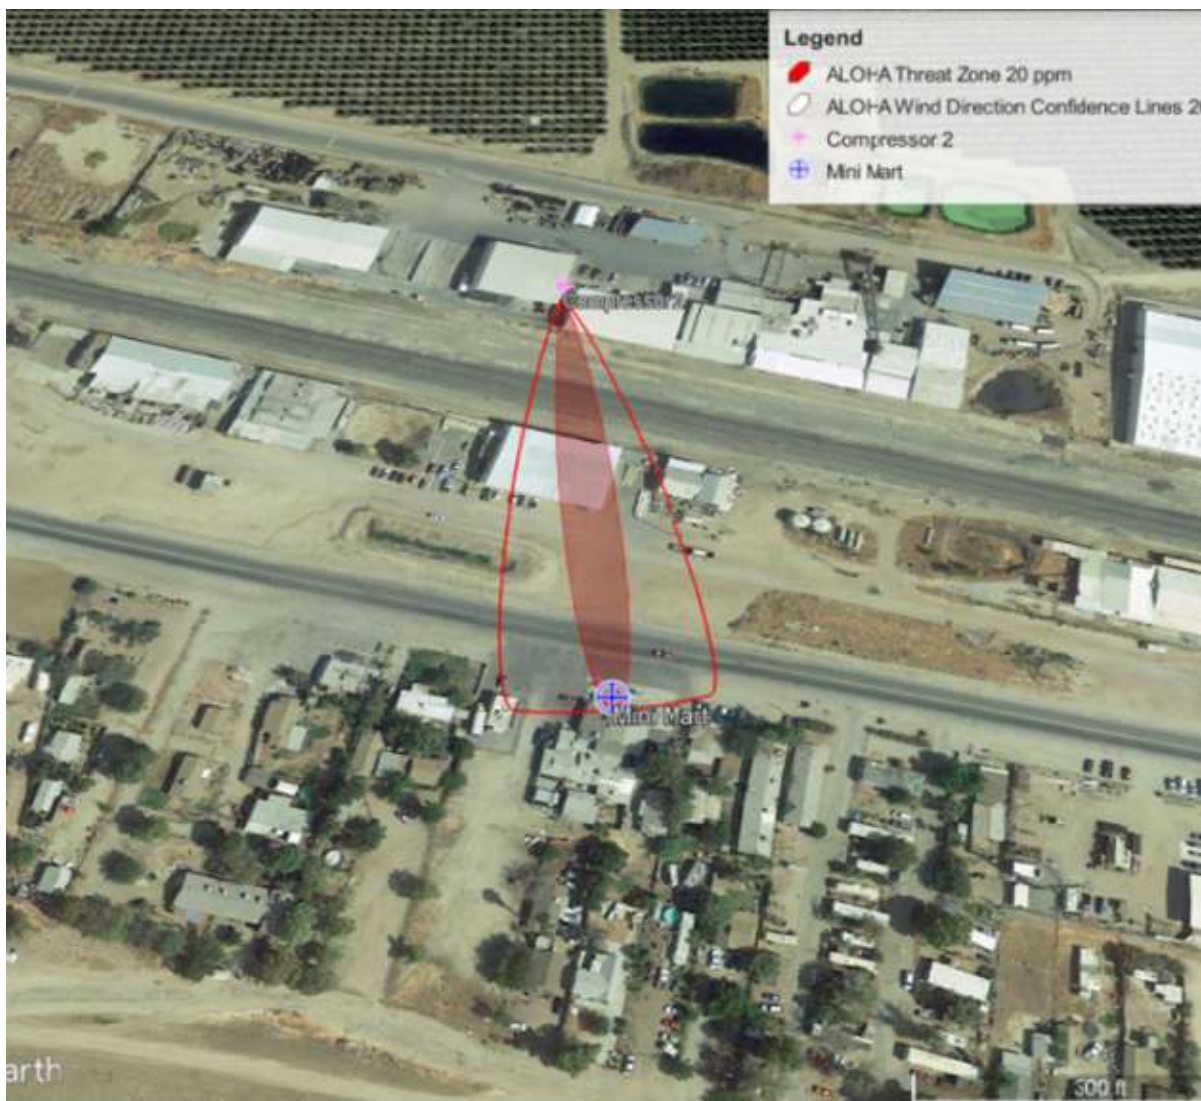
Figure 11. Computer-Generated Ammonia Cloud Overlayed on Satellite Imaging

Using the software which generated the image in Figure 11, it was determined that an ammonia release rate of 0.935 lbs./min would result in an ammonia concentration of 20 ppm at the mini mart. The ammonia release lasted approximately 307 minutes, and the amount released is calculated below.

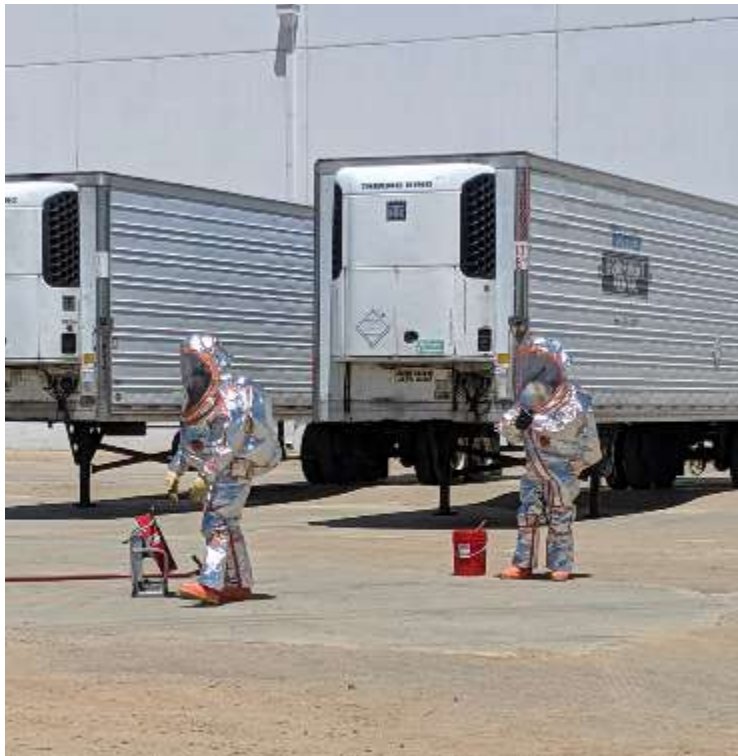
Figure 13. First Responders at the Scene in HAZMAT Suits

Notifications of the leak were made, and the fire department, a refrigeration contractor, and a Hazmat team arrived on site. The ammonia detector concentration display was visible from outside the machinery room by using binoculars. The detector displayed an ammonia concentration of 800 ppm, which was the highest concentration it was capable of displaying. The Hazmat team donned Level A Hazmat suits (Figure 13) and entered the machinery room where they recorded a peak ammonia concentration of 8,300 ppm.

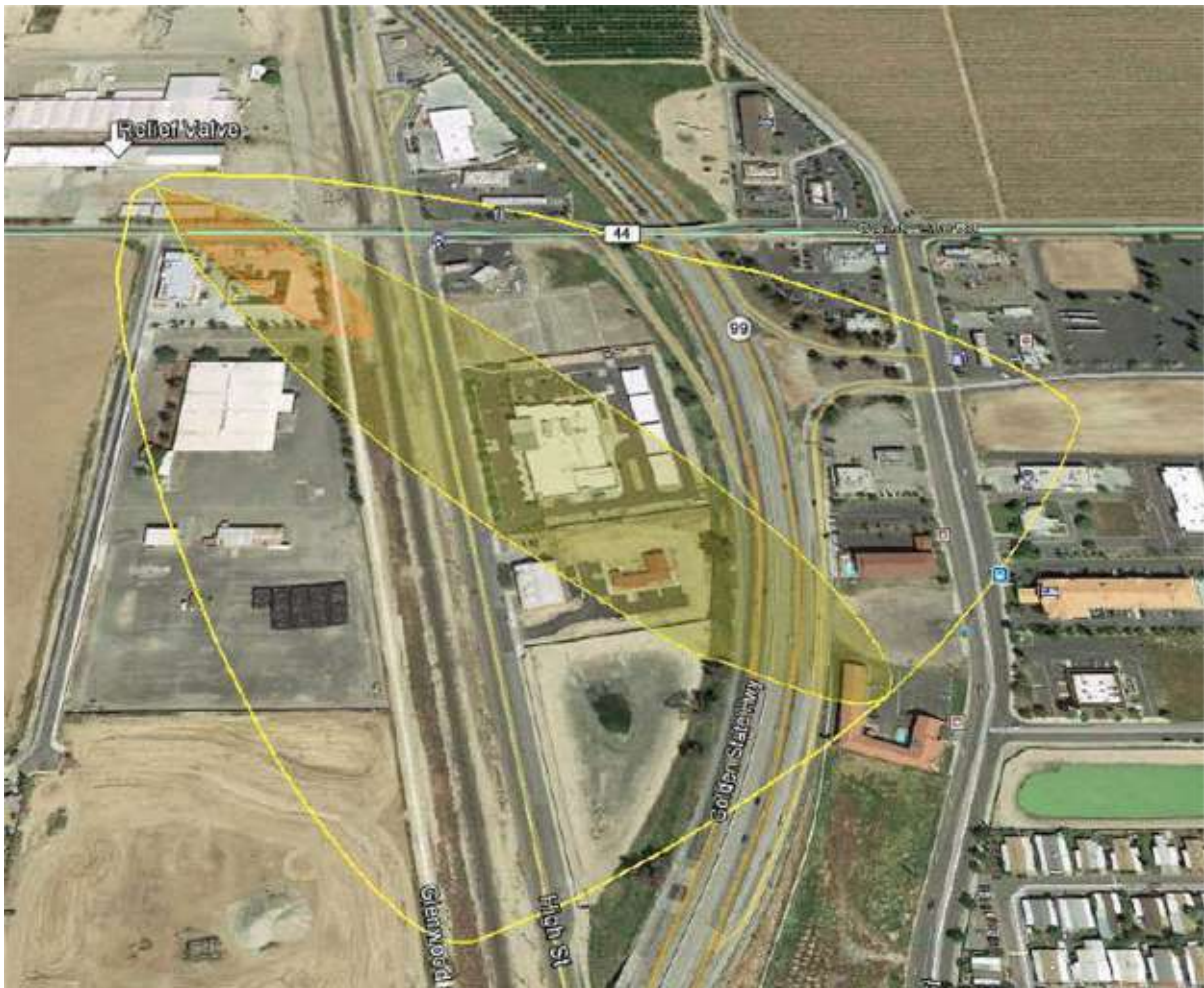
Figure 20. Computer-Generated Ammonia Cloud Overlaid on Satellite Imaging

The relief valve terminated to the atmosphere above the facility roof. The termination point exceeded the requirement of being located at least 7.25 feet above the roof. However, due to the close proximity of public receptors (Shown in Figure 20), the following recommendation was made following the release:

*“Deliberate consideration should be given to installing an ammonia diffusion tank because of facility location to the freeway and local businesses.”*

Although the facility was not required to install a diffusion tank per the applicable RAGAGEP, it would have significantly reduced the chance of employee injury and exposure to nearby receptors. In some instances, diffusion tanks can be a prudent defensive strategy in containing ammonia vapor during a release.

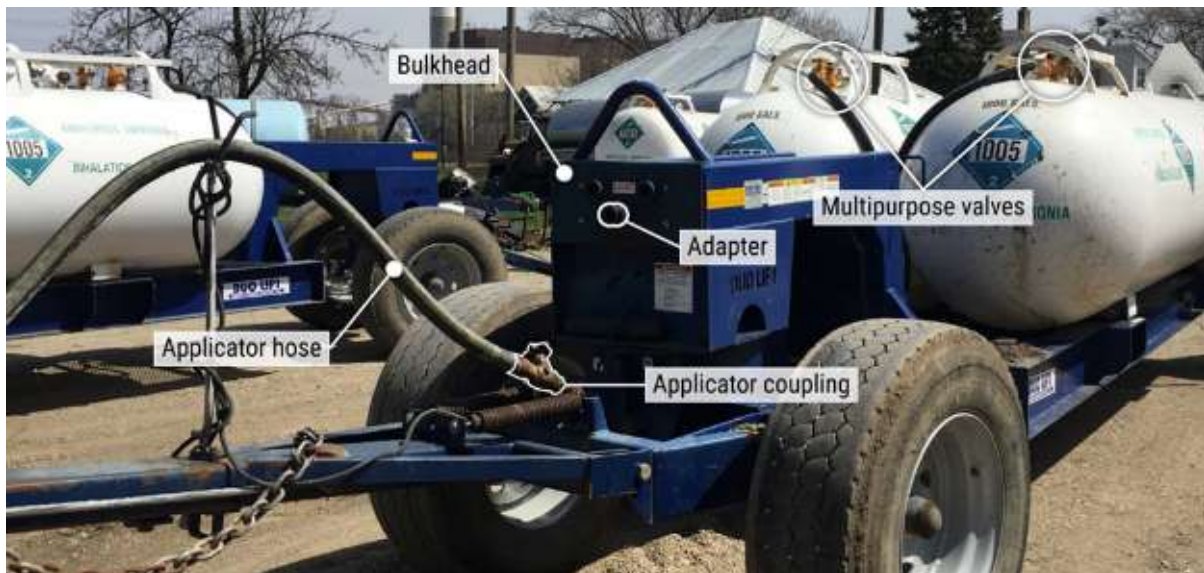
Figure 22. Nurse Tank Trailer - Image courtesy of the National Transportation Safety Board

A tractor was transporting a pair of two-ton nurse tanks filled with ammonia when an applicator coupling on the tank became unscrewed. Figure 22 below displays a typical applicator coupling used for transporting nurse tanks. Due to the foggy weather, the ammonia did not dissipate into the atmosphere but stayed low to the ground, exposing many people in the nearby town.

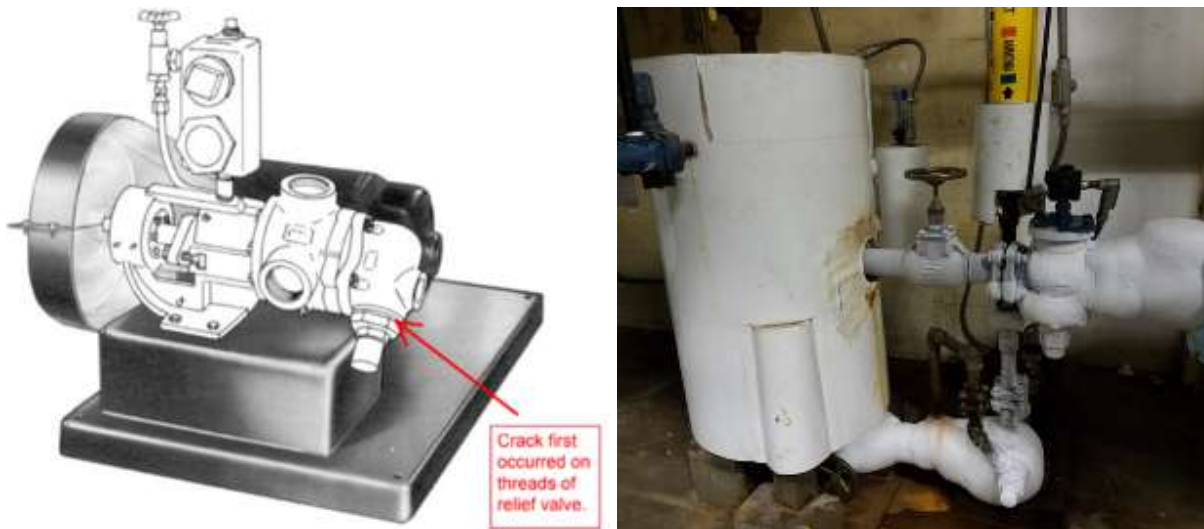
Figure 28. Pump Sketch (Left) and Installed Pump (Right)

The ammonia refrigeration system at the food processing/cold storage plant was configured with a liquid transfer vessel and transfer pump shown below in Figure 28. The valve in question was located in the pump bypass piping.

Investigation into the incident revealed that the stress crack formed from years of frosting and thawing cycles. The cycles allowed water to freeze and expand, then contract as the ice melted. This phenomenon is commonly seen on roadways where freezing and thawing of water results in crack formation.
